Analysis of the Accidental Explosion at Pepcon, Henderson, Nevada, May 4, 1988

Jack W. Reed

ANALYSIS OF THE ACCIDENTAL EXPLOSION AT PEPCON,
HENDERSON, NEVADA, MAY 4, 1988

ABSTRACT

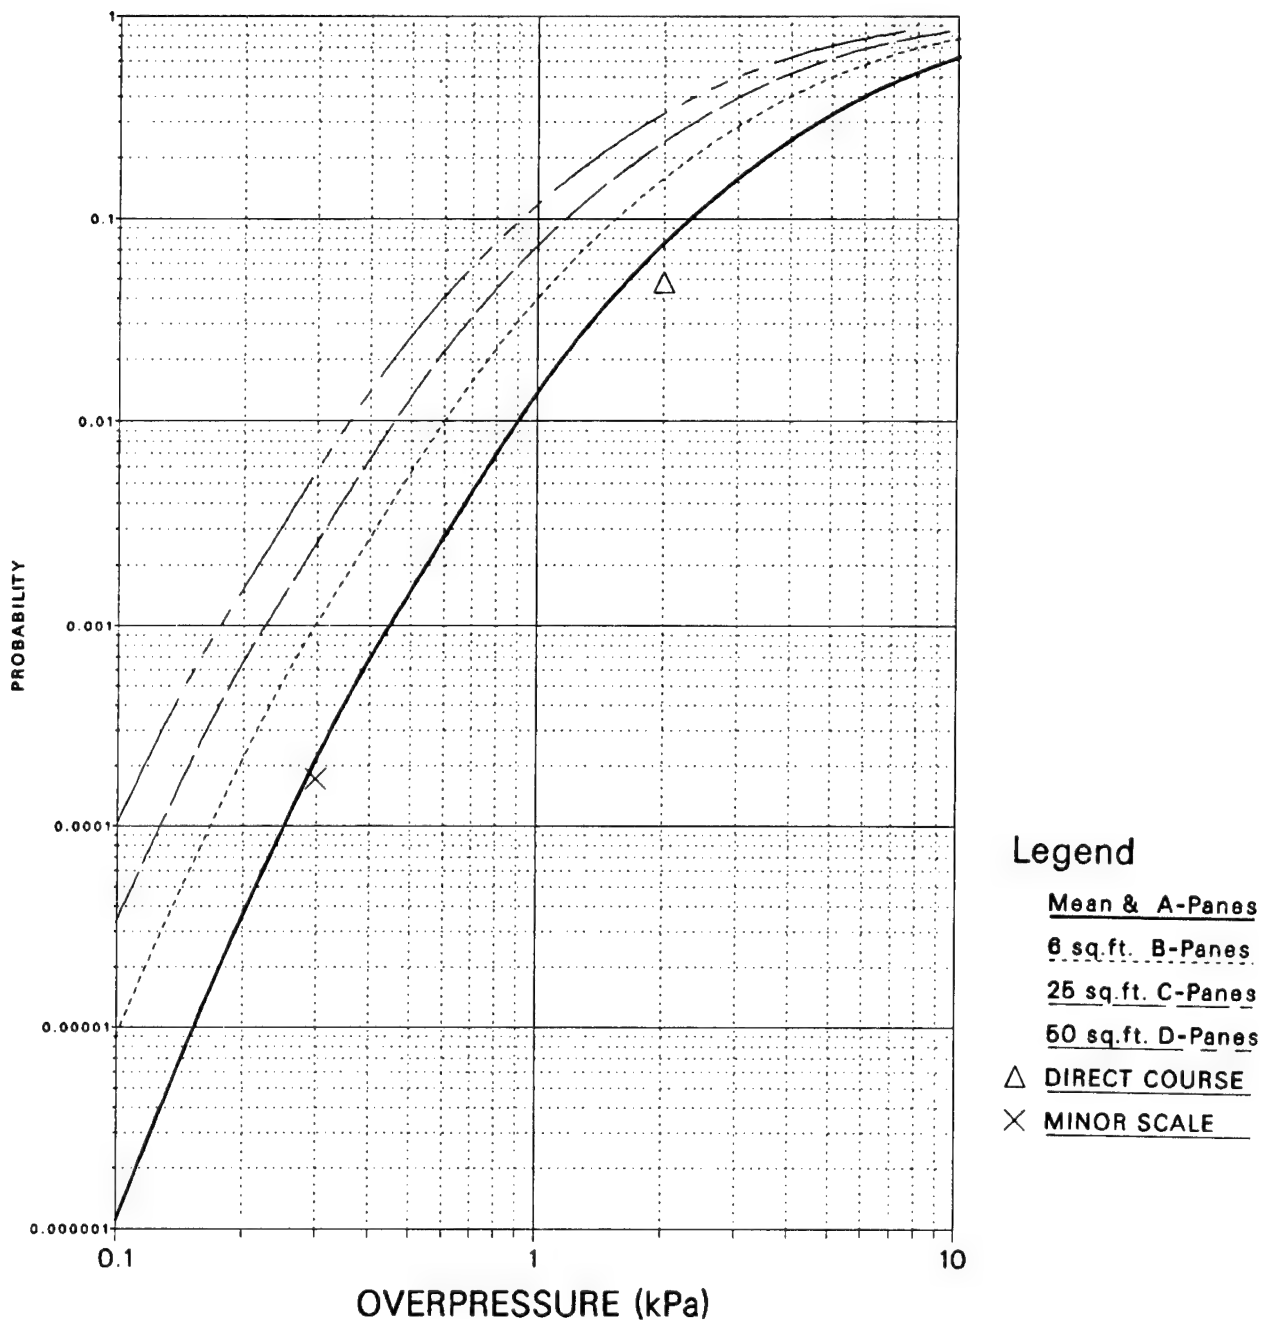
Medina results were also categorized by windowpane area in Figure 5 for small casement windows, typical double-hung windows, large picture windows, and very large store windows. An expression for the mean breaking load, b , for square plates is

Figure 5. Window breakage probability versus incident side-on (gaged) overpressure. Mean curve based on 1964 San Antonio, Texas, window pane size distributions.

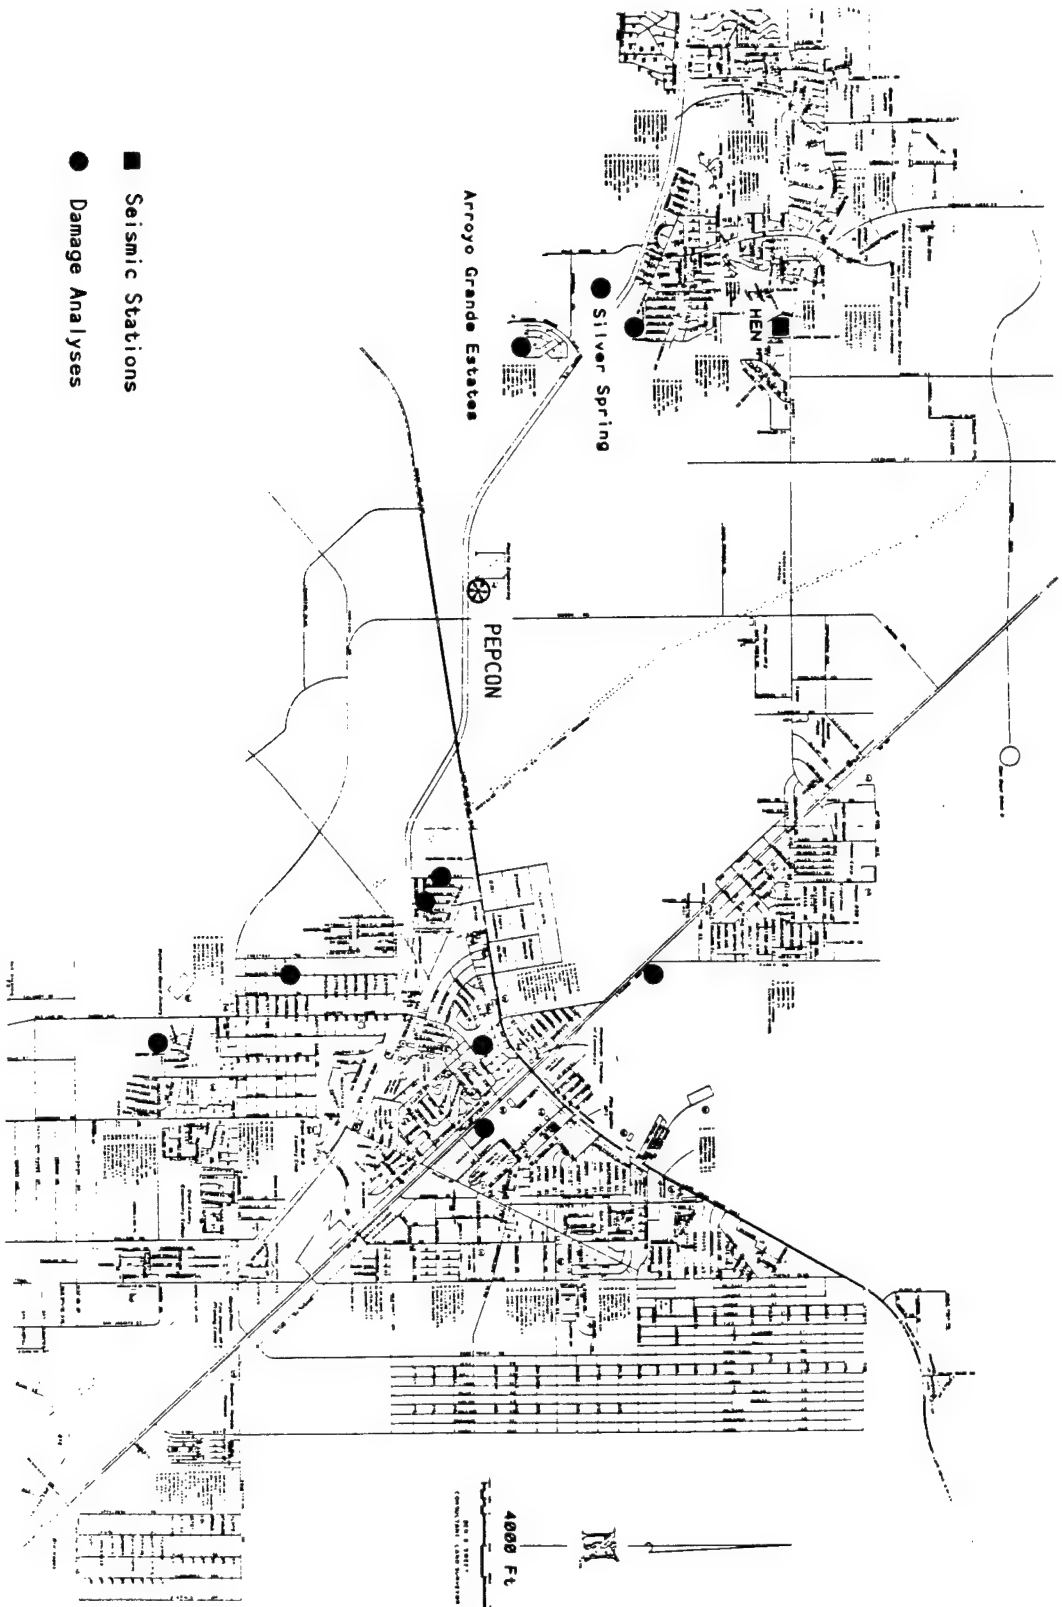
Figure 9. Street map of Henderson, Nevada, (from Henderson Chamber of Commerce), with explosion site and locations for damage analyses.

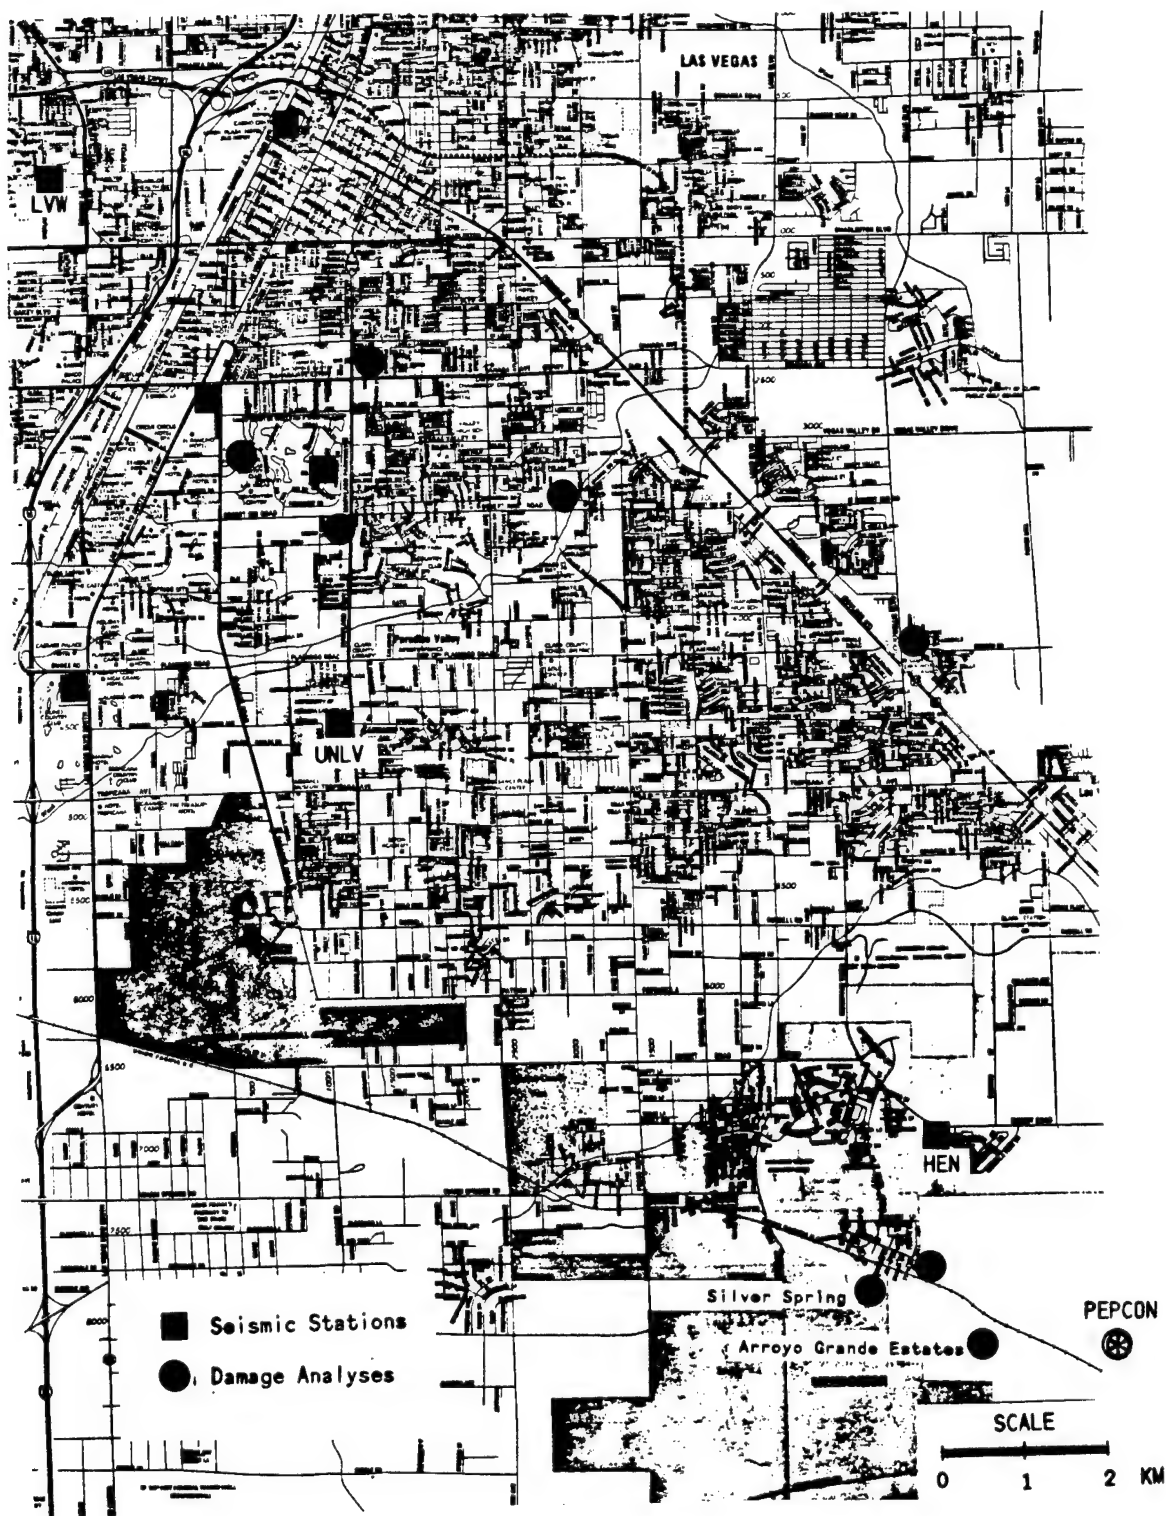
J. L. Woodruff, of URS/John A. Blume & Associates, seismic consultants to DOE-NVO, lives near Boulder Highway and Flamingo Road, Las Vegas, about 9 km from the blast according to the Las Vegas map in Figure 11. He reported that about one-third of his neighbors had window damage. This was interpreted as 330-Pa overpressure, near the -10 m/s gradient curve and clearly lacking any strong enhancement in spite of their generally downwind direction. They were probably in the "silent zone" between focused caustic arcs.

Continuous recordings are made at Station S-2, at the University of Nevada Las Vegas (UNLV) Chemistry Building, off Maryland Parkway and south of Flamingo Road, and at the Las Vegas water pumping plant, S-8, north of Charleston Avenue in northwest Las Vegas, as shown in Figure 11. It had been hoped that these recordings could be used to determine times for the various reported explosions, but it appears that only the first and third explosion were strong enough to cause a readable oscillation. Some recorders were not even triggered to operate by ground motion arriving from the first explosion wave, and only recorded the airblast wave. Clear audibility of only two blasts was also reported (R. C. Bass, SNLA-7111, pers. comm., 1988) from a point on Sahara Boulevard, between Paradise Road and Maryland Parkway. On the other hand, as previously cited, a video-camera recording gave both video and audio indications of a moderately large explosion about one second before the final, large blast.

Figure 11. Street map of Las Vegas, Nevada (from Rand McNally), with explosion site and locations for damage analyses.
